## FINAL REPORT OF SPECIFIC PURPOSE LIDAR SURVEY

### LiDAR, Breaklines and Contours for Okaloosa County, Florida

State of Florida  
Division of Emergency Management  
Contract 07-HS-34-14-00-22-469  
Task Order 20070525-492718a  
PDS Task Order B

October 30, 2009

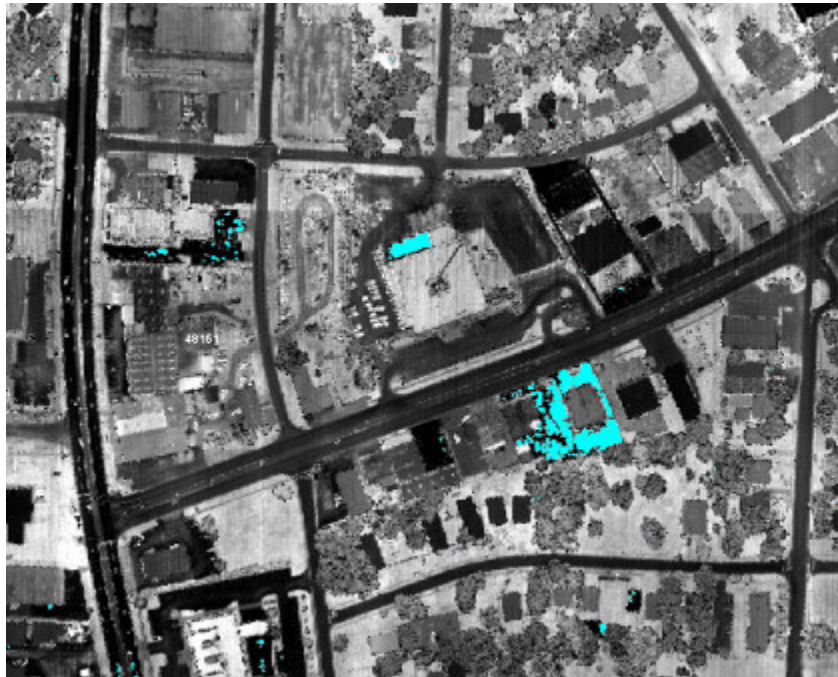
For Okaloosa County, additional voids were found on features such as residential and commercial rooftops and paved surfaces in parking lots and on roads. Instances of these voids occur randomly throughout the dataset (Figures 3 & 4). All voids found were reviewed and determined to be within acceptable ranges.

**Figure 11: Overview showing areas of data voids in parking lots and buildings**

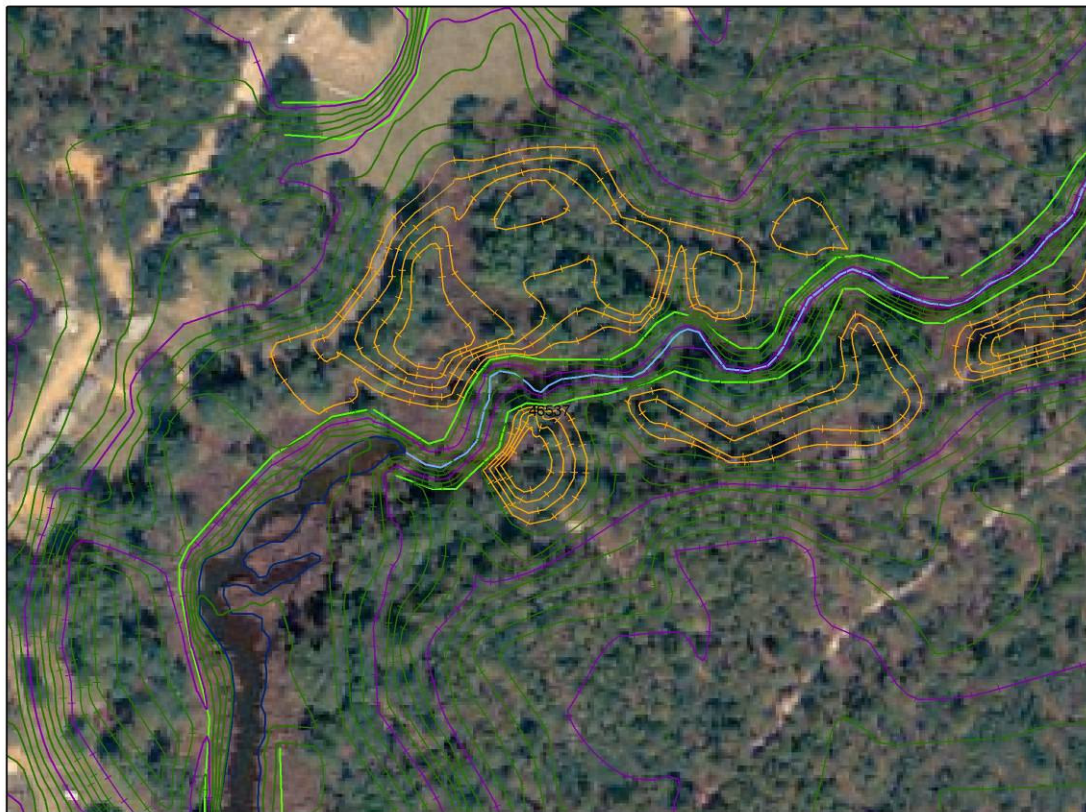
Linear hydrographic features are correctly captured as three-dimensional breaklines – single line features if the average width is 8 feet or less and dual line features if the average width is greater than 8 feet. Each vertex maintains vertical integrity. Figure 2 shows example breaklines and contours of linear hydrographic features.

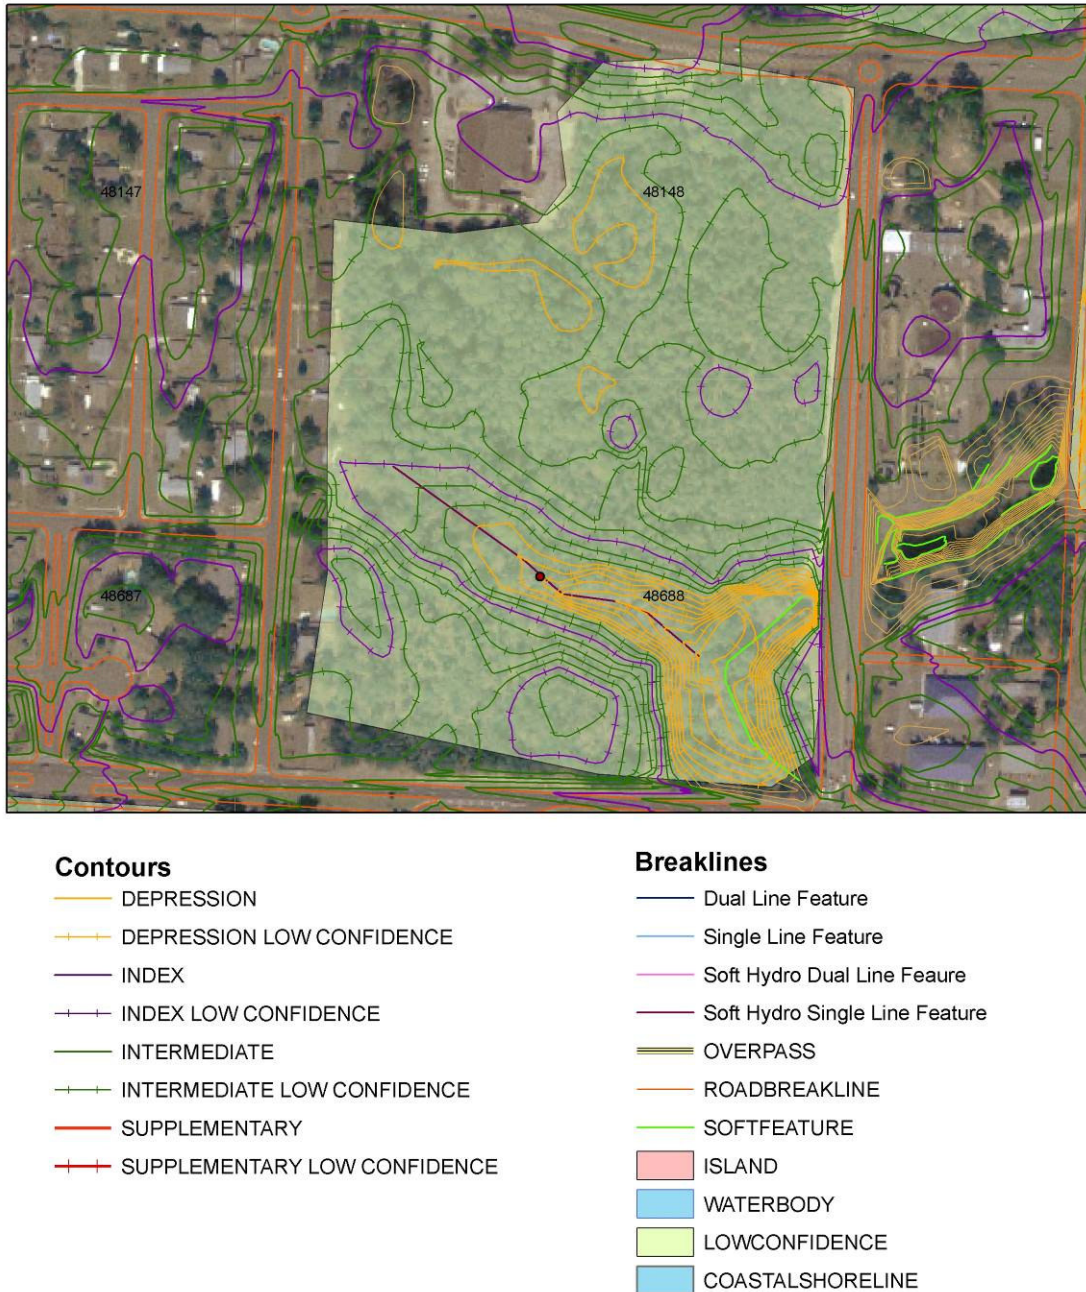
The apparent boundary of vegetated areas (1/2 acre or larger) that are considered obscured to the extent that adequate vertical data cannot be clearly determined to accurately define the DTM are correctly captured as two-dimensional features with no z-values. Figure 8 shows example breaklines and contours for low confidence areas.

**Figure 8. Example low confidence area feature breaklines and contours from tile # 48148 & 48688**
